# Bill<sup>to</sup>Bill<sup>TM</sup> 300XE

currency management system

## Serviceability Manual

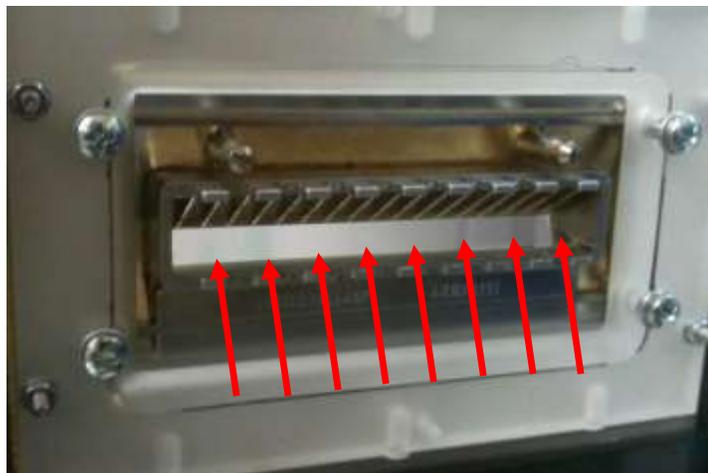
Dispenser Bezel:

Both the bill validating head and the dispenser bezels attached to the door should be now inspected for any damage caused by a vandalism attempt. If any such excessive damage is found (such as dent or scratches in the bill entrance or perimeter areas) please contact our technical support department.

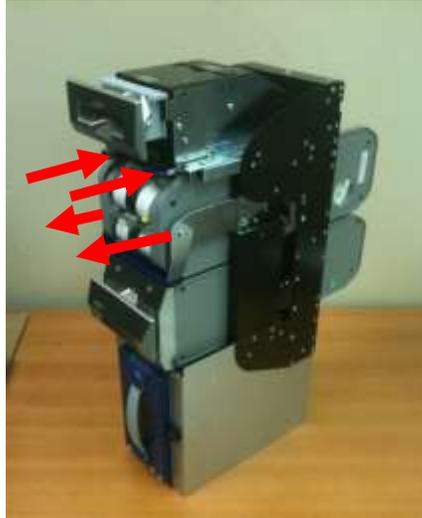
First, remove the chassis out of the Bill-to-Bill™ unit by pressing the two blue buttons inwards and pulling the handlebar out.

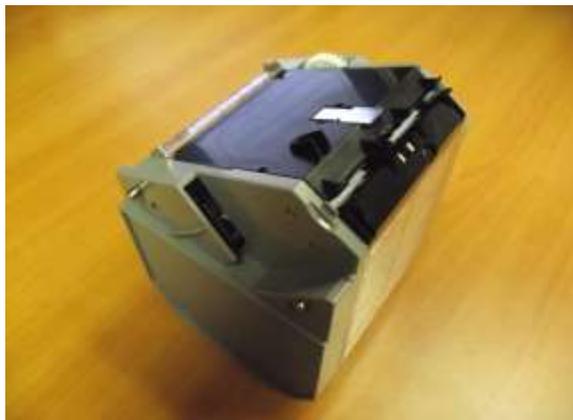
After the recycling cassettes have been removed from the chassis in previous step, turn the module around in order to get the door to face you.

This reveals two sets of sensors, one at the edge of the cover, and the other at the edge of the recycling cassette. The sensors on the cassettes can be cleaned using a cotton swab without opening the cover. However, do not use the compressed air can in this case.

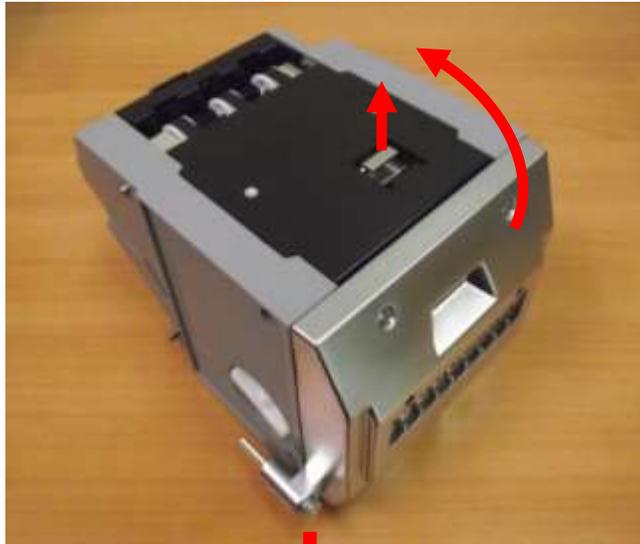
The dispenser must be thoroughly cleaned since it interfaces with the environment and is susceptible to a substantial amount of dust and debris. There are three sets of sensors in the dispenser that must be taken care of. The first two can be found by carefully opening the top cover. They are located at the bottom floor of the dispenser. These sensors must be cleaned using a cotton swab.

Older models of dispenser may only have one sensor at the bottom.

The third sensor is located at the bill entrance (entrance of the bill from the path switch). It should be cleaned using a new cotton swab

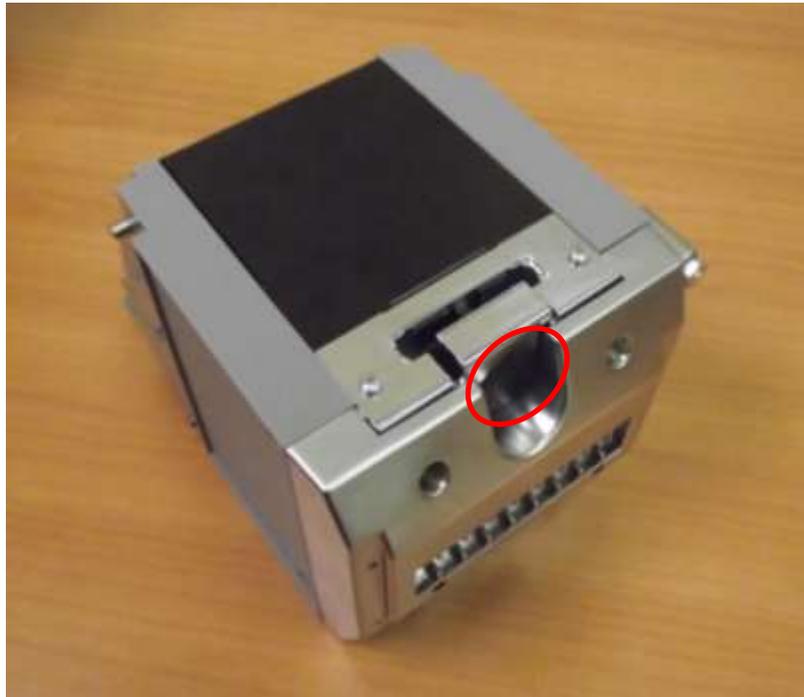
Additionally, special care should be taken when examining the cam lock mechanism on the dispenser. In many cases it may be bent or misshapen. This could compromise the security of the unit. Ensure that it is replaced as soon as any damage has been detected.

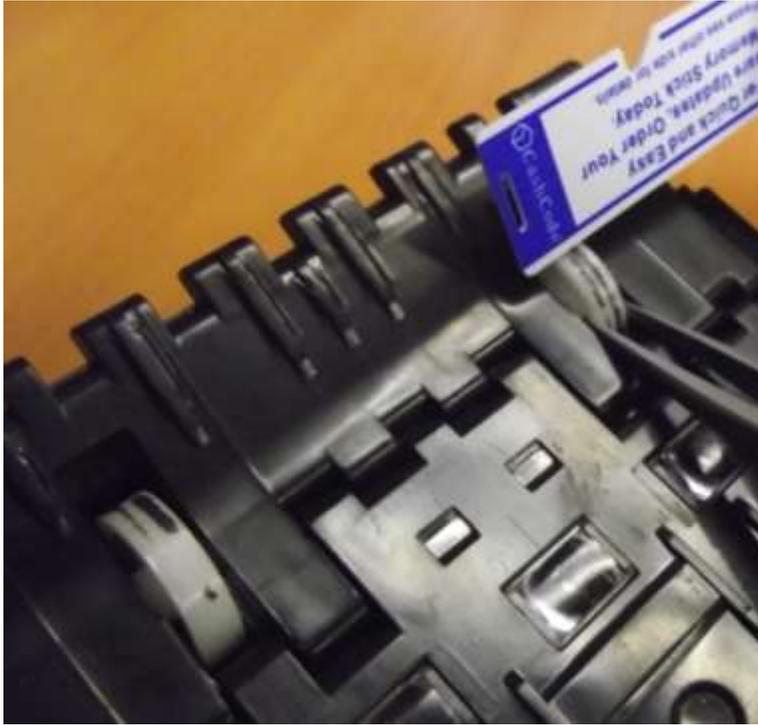
Ensure the dirt removed does not fall through the voids on the surface into the machine.

The o-rings are then cleaned using the alcohol-free LCD cleaner. Spray the antistatic microfiber cloth sparingly and wipe the o-rings. For best result, move the cloth in a direction perpendicular to that of the direction of rotation, turn the wheel and repeat.

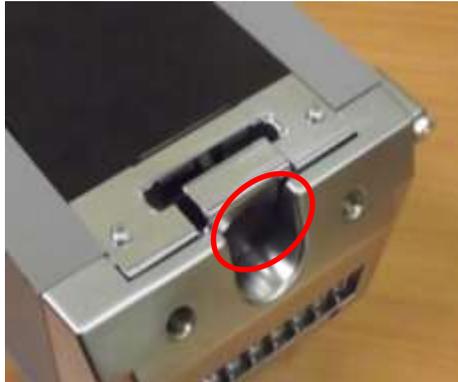
As before, ensure no physical damage is observed on the dispenser and report any excessive damage if found to a certified technician for further analysis. Special care should be taken when examining the cam lock mechanism on the dispenser. In many cases it may be bent or misshapen due to the mishandling of the unit which will compromise its security. Ensure that it is replaced as soon as any damage has been detected.

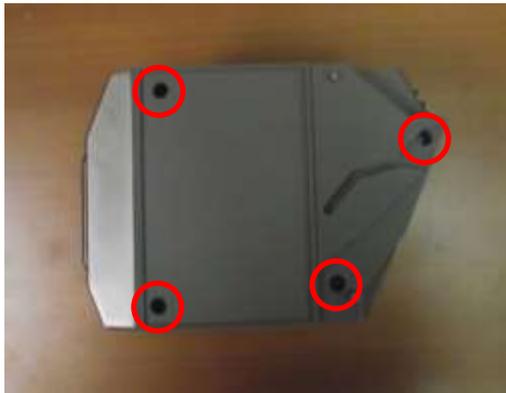
Next, using the Phillips screwdriver, unscrew the 4 bolts on each side of the dispenser.

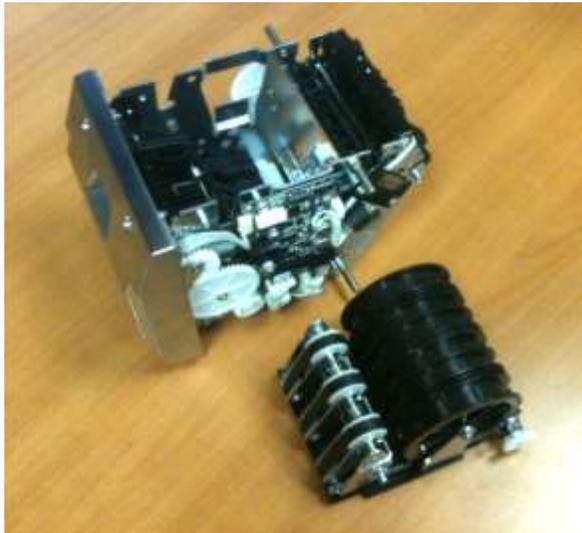
Once the dispenser cover is removed, there is an easy access to the six belts and two sets of sensors inside the dispenser. The same sensors that were cleaned using the cotton swabs in level 1

can now be cleaned more thoroughly.

More importantly, the belts are cleaned using the LCD cleaner and an anti-static microfiber cloth. The belts can be manually rotated and cleaned all round.

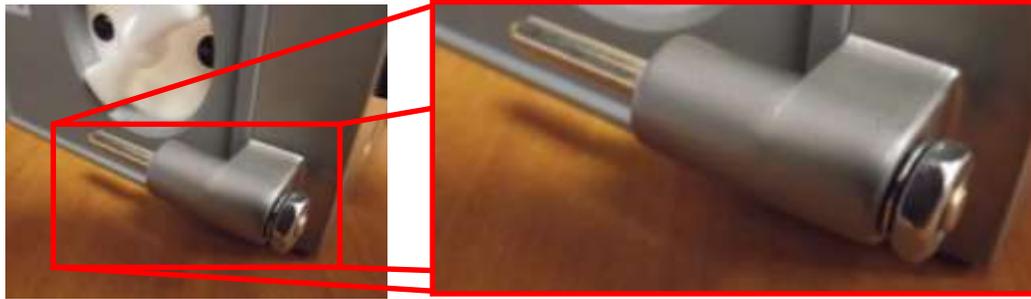
If the dispenser has a metal bezel, ensure the grounding pin is properly interfaced with the connector on the chassis as it is installed back into place and that it is firmly connected to the dispenser.

Finally, using a can of compressed air, clear the inside of the dispenser from any dust, ensure this is done diligently since the dispenser is prone to more dust accumulation than most other modules in the Bill-to-Bill™ 300XE unit.

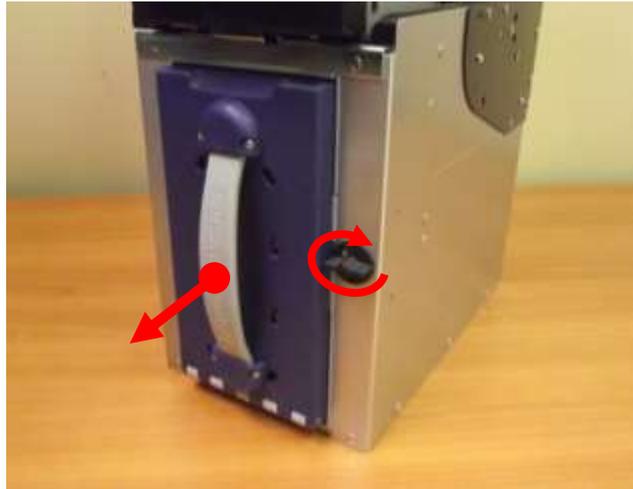
At this maintenance level, the cashbox should be removed from the Bill-to-Bill™ 300XE unit by unlocking the cashbox compartment and pulling the handle of the cashbox outwards.

First, inspect the box for any dents and other possible damage and contact a technician if serious damage is found.

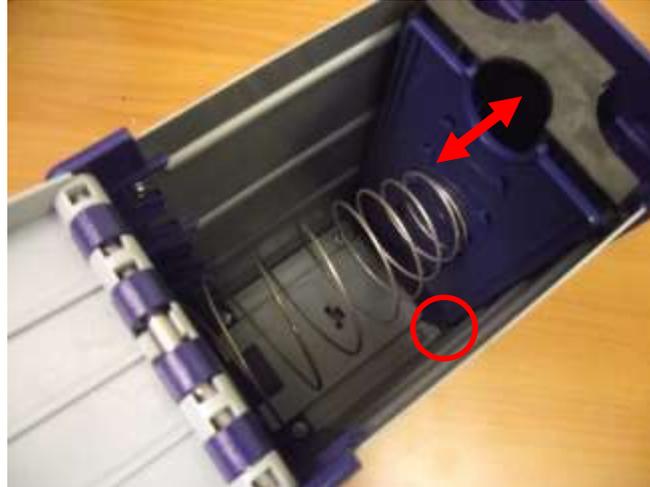
Next, inspect the inside of the cashbox for any damaged surfaces. Ensure the plate stacking the bills moves freely and that the pins used by the plate for sliding are not bent or damaged. The stacking plate supported by the springs must be straight. If any damage is found, please contact a technician for further analysis.

Using a can of compressed air, clear out any dust that might have accumulated at the back of the cashbox along the tracks of the bill stacking mechanism to ensure the cashbox reaches its maximum bill capacity.

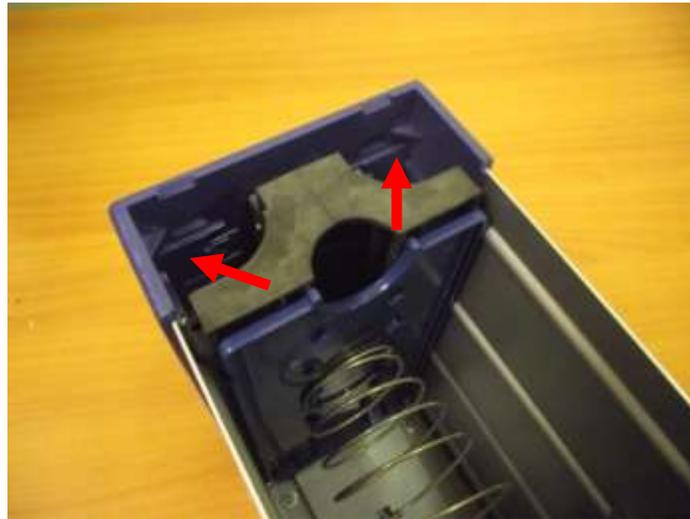
Visually inspect the cashbox cam used to lock the cashbox and ensure it is no broken and does not show any attempts of vandalism. Damaged cams will compromise the security of the cashbox and must be checked often. Replace cashbox immediately if damage is detected.

Additionally, inspect the housing of the cashbox. Visually verify that the cable harness does not have damaged wires, the red security switch springs back when it is pressed and none of the other metal parts are bent.

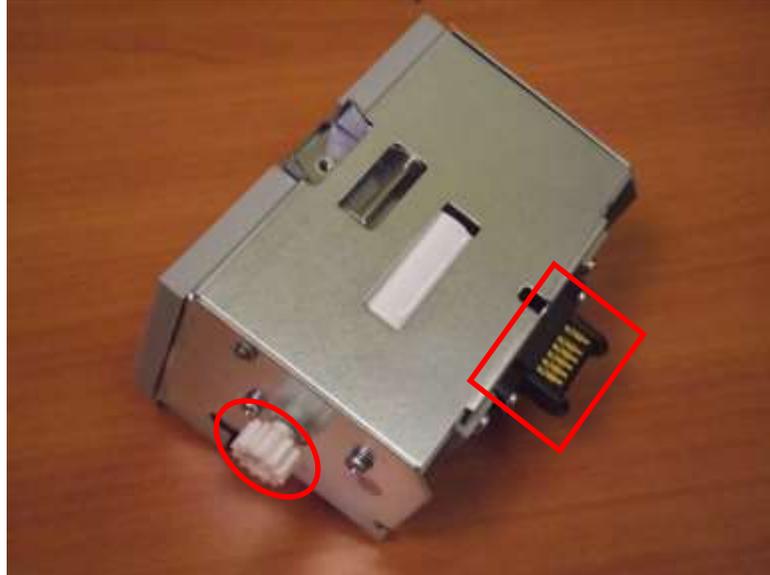
After the interface has been removed, check to ensure that the main connector does not have too much play about it and none of the teeth on the motor gear are chipped or broken.

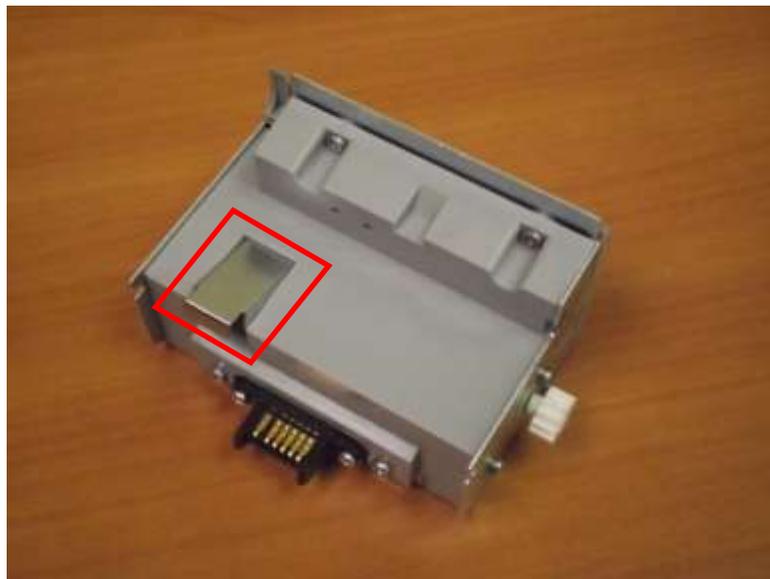
Turn the module around and verify the main latch is not bent and it springs back to its original position once it is pressed and released.

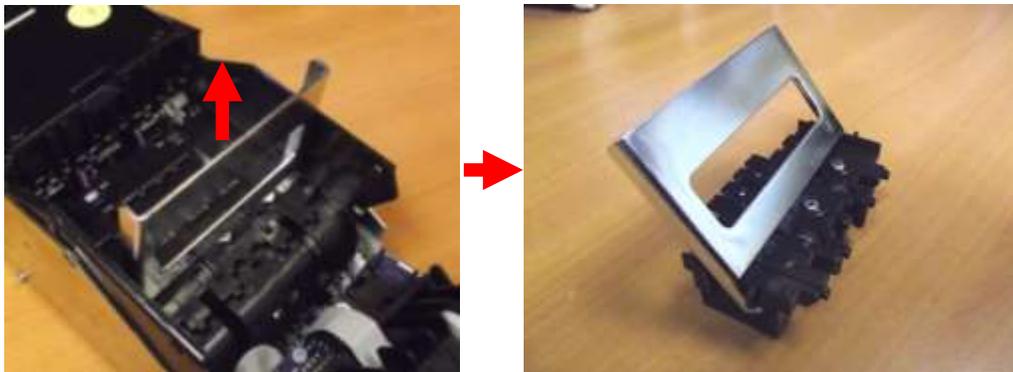
First, insert the extractor into the two channels on the two sides of the lower Sense-A-Click™ module. The small teeth on the extractor should be pointing away from the bezel. Next, move the extractor away from the bezel as to flush it with the Sense-A-Click™ module and put it at 90 degrees to the surface of the bill validating head.

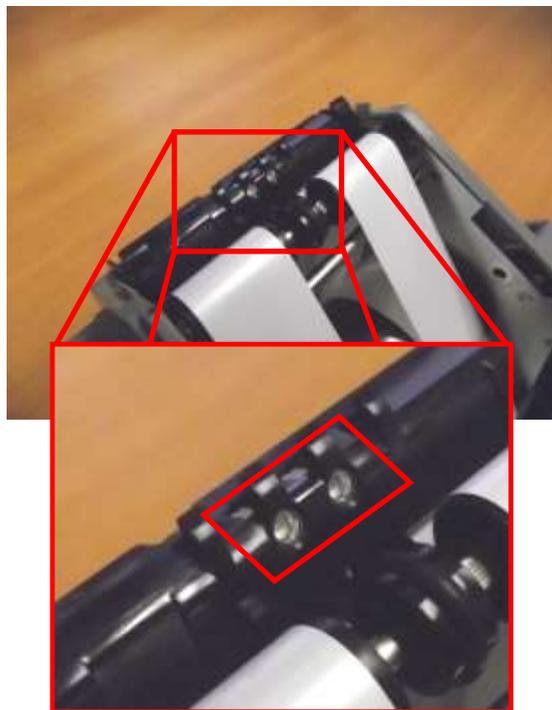
Observe the two sensors located at the edge of the cover and edge of the opening on the cassette. In order to ensure proper bill detection, ensure the sensors are flushed with the surface as mentioned before.

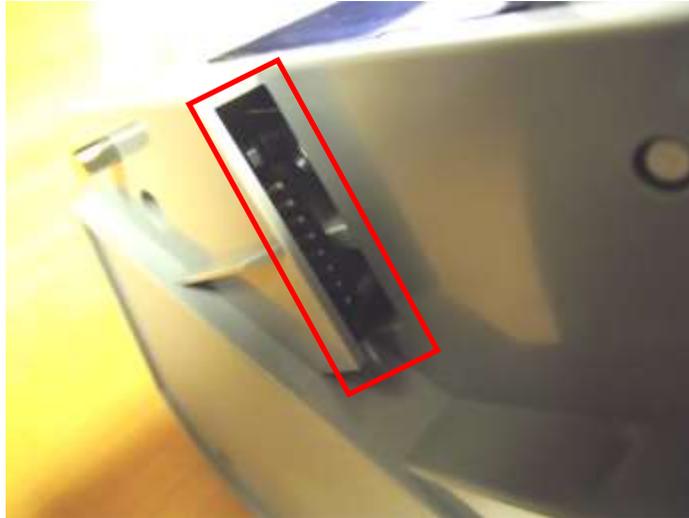
Also, ensure the interface connectors are intact on all recycling cassettes and do not show excessive signs of wear.

If any damage is detected, replace the connected along with the connector wire (0500109) by removing the two side covers of the cassette and unclipping the wire.

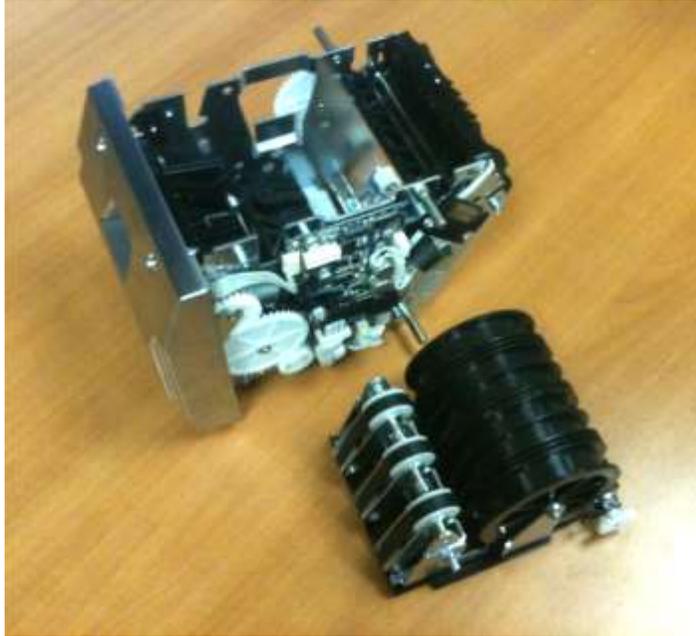
Then lifting up the cover will reveal all sensors and belts.

Optional: Turning the dispenser over would reveal the shutter and drive motors. It is recommended to replace these motors during Level 3 maintenance at **540,000** cycles (0300052-02).

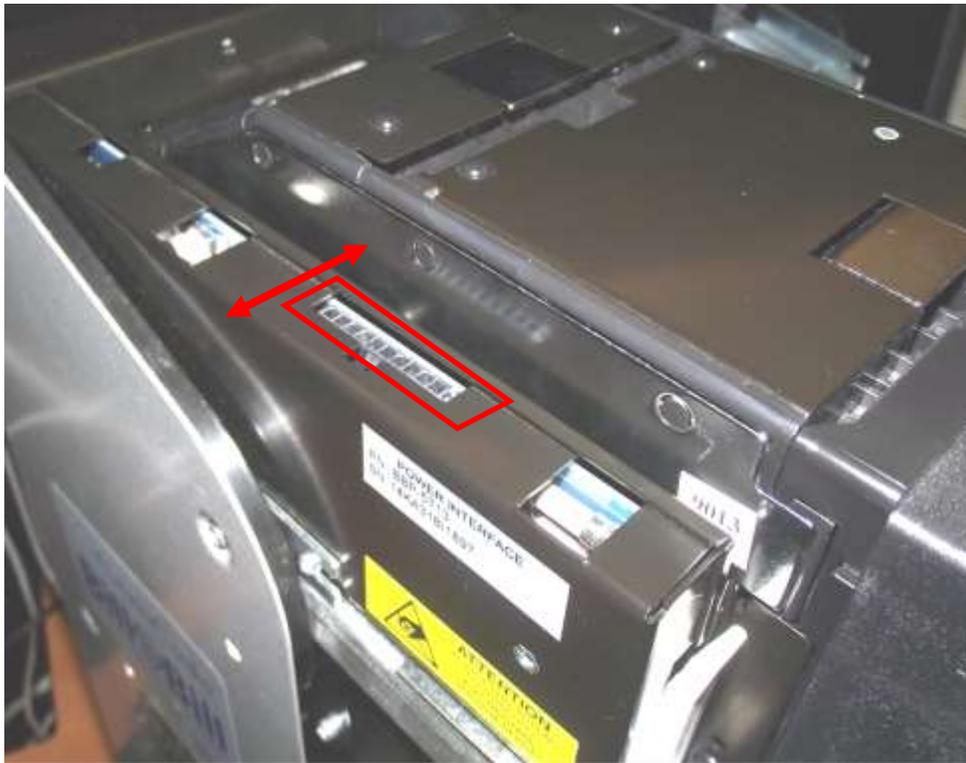
The power interface is an essential life-line for the Bill-to-Bill™ 300XE unit. Ensure that the connector is not loose and has no play about its location. Also, ensure the pins inside each of the 10 slots on the connector are straight. If any damage is detected, the power interface must be replaced.
