BilltoBill™ 300

currency management system

Serviceability Manual

User's Manual (Revision2)

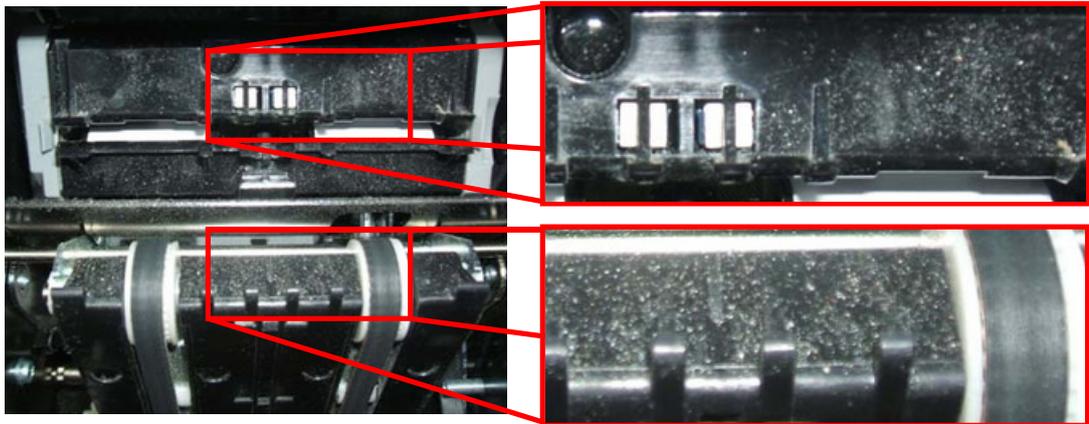
- Mild dust is being held loosely on the surface and can be removed simply by either using a can of compressed air or by cleaning it lightly using a lint-free microfiber cloth

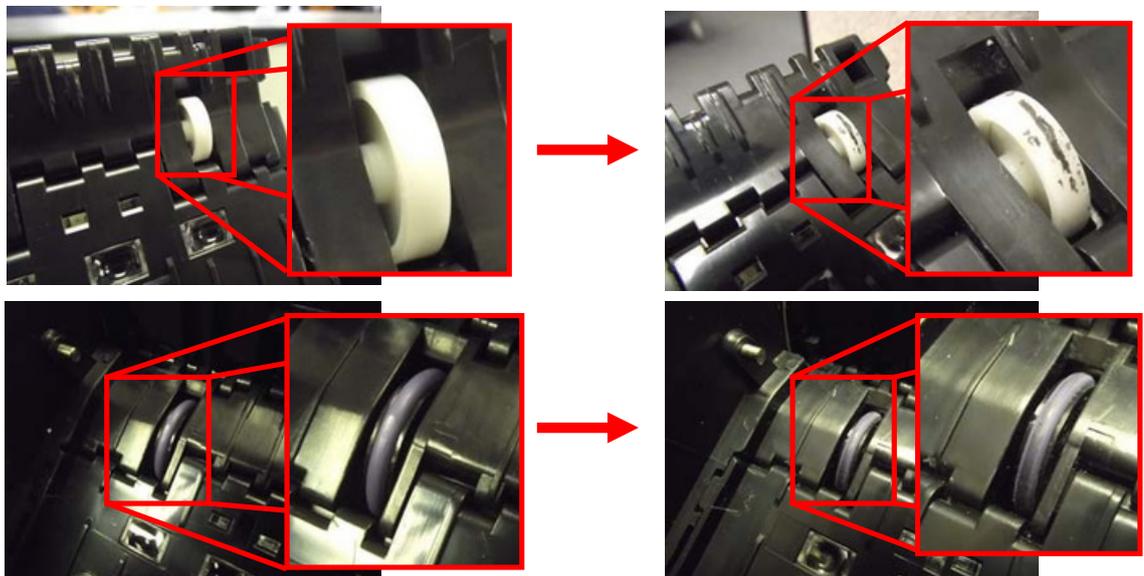
- Moderate** – The moderate level includes dust and debris that has been mixed with oily residue and requires additional effort in order to remove it from the surface (this can be seen mainly on rollers which place the dirt under pressure causing it to compact on its surface)

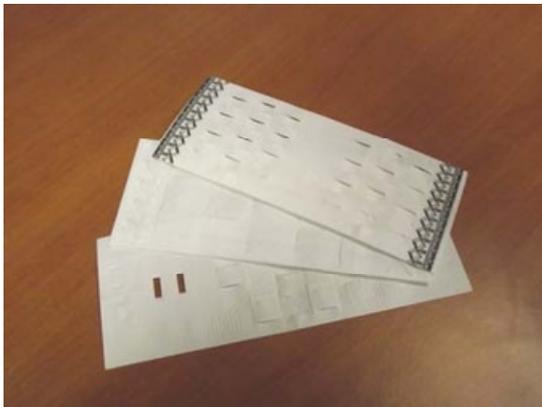
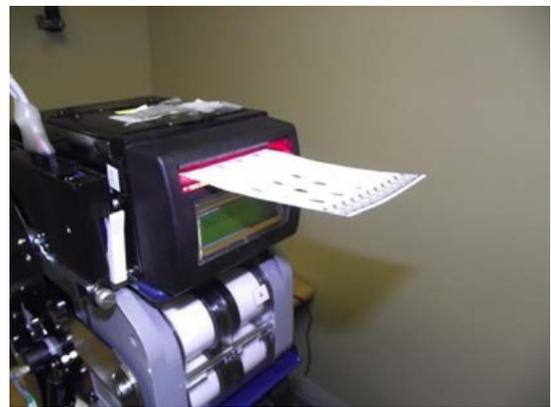
Method 1:

When using the cleaning card, the unit is not unplugged. This step is taken while the unit is in its normal operating mode. The card can simply be inserted into the bill entrance, it will clean the sensors, aligning mechanism and path on the way into the bill validator and once again on its way out after the “bill” has been rejected. The card can be inserted several times for better results.

The cleaning card may replace only one service period before the bill validator must be cleaned manually as outlined in Method 2

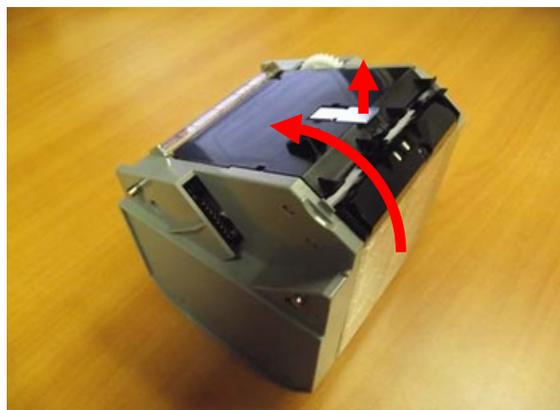
After the recycling cassettes have been removed from the chassis in previous step, open the cover

This reveals two sets of sensors, one at the edge of the cover, and the other at the edge of the recycling cassette. The two sets of sensors have to be cleaned using a cotton swab and then sprayed with compressed air to remove leftover loose dirt.

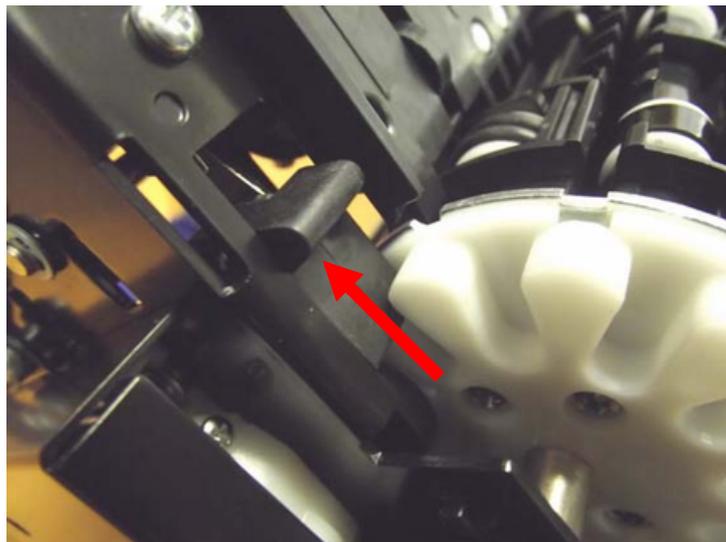
In some cases, the switch lock might interfere in the removal of the switch and has to be depressed as the switch is taken out of the chassis.

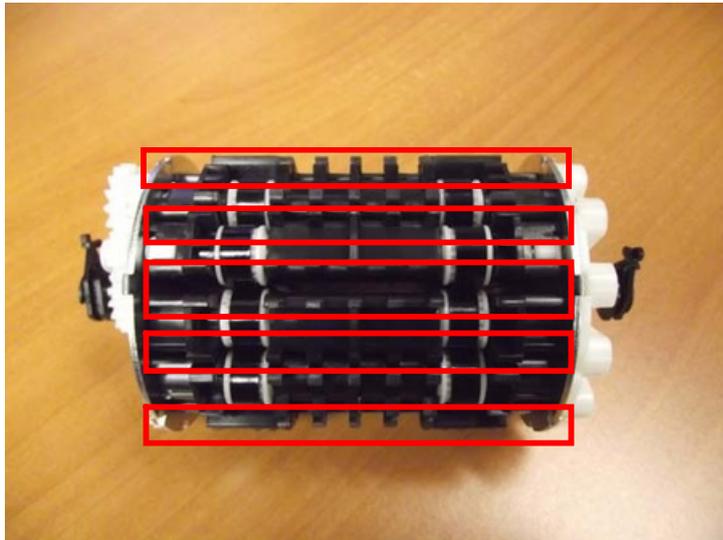
After the switch has been removed, using a can of compressed air, spray each slit thoroughly. Also spray all other surfaces including the gears end and the stepping end (index disk) of the switch. This will prevent the dust from wearing the surface of the teeth on the gears and that of the index disk.

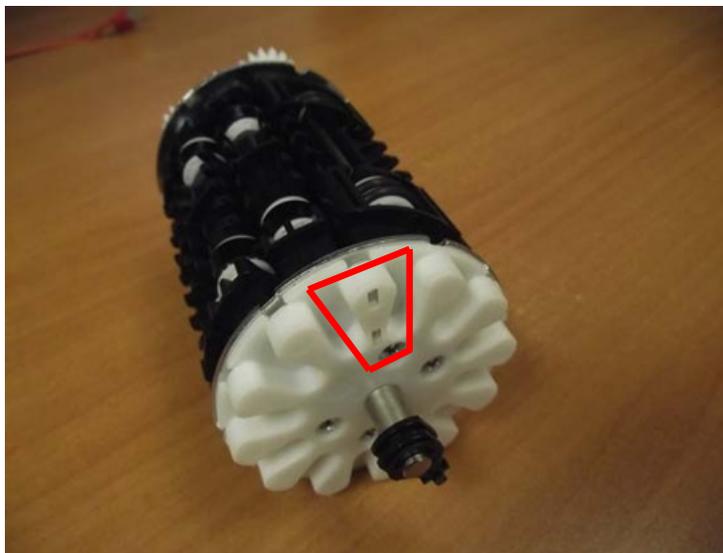
Finally, find the location sensor on the index disk and clean it using a new cotton swab.

Do not clean the gears using cleaners or the micro-fiber cloth. This will remove the lubricant and will dramatically shorten the lifespan of the path switch.

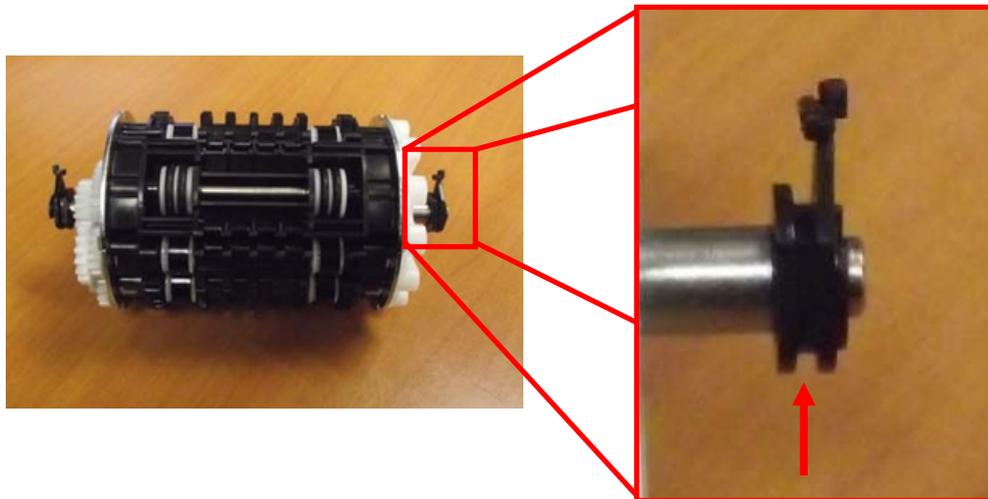
In order to ensure it is properly installed, first, insert the switch back into the housing while holding the bearings with the snap pieces pointing upwards (match the gears on the switch to the side with the gears on the chassis).

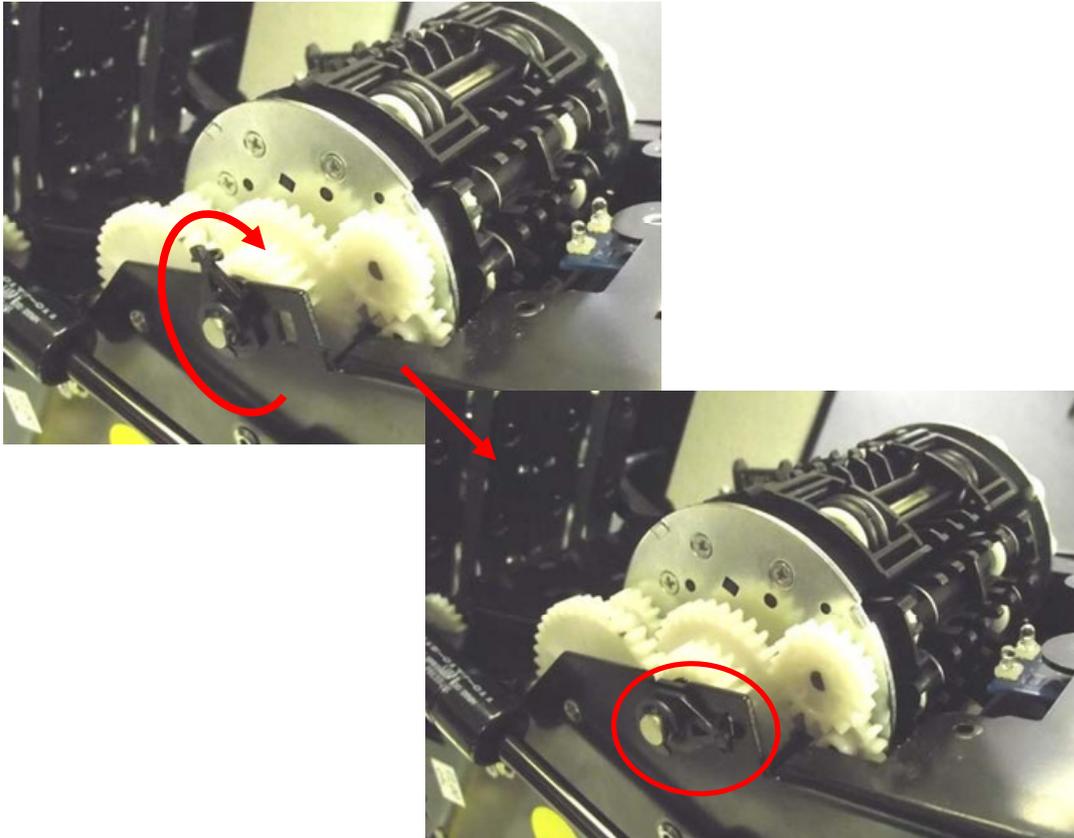
After the switch has been inspected to sit tightly inside the chassis with no gaps, the switch can be secured by rotating the bearing snaps 90 degrees on both sides towards the securing slot.

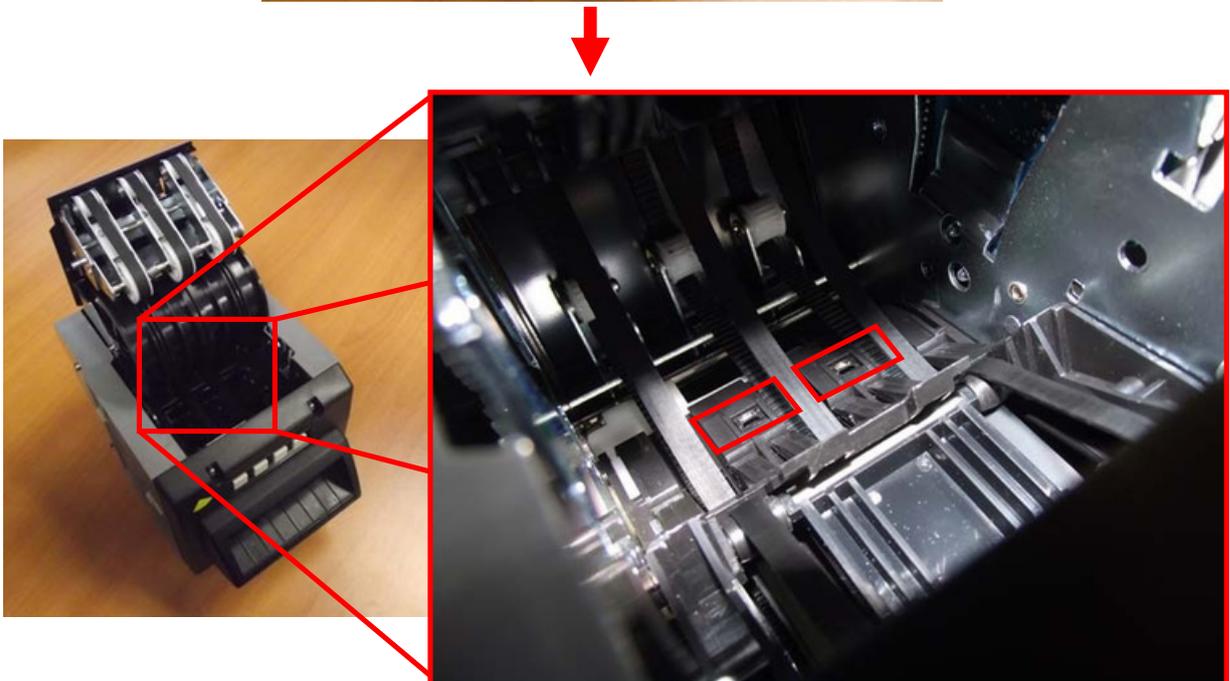
The dispenser must be thoroughly cleaned since it interfaces with the environment and is susceptible to a substantial amount of dust and debris. There are three sets of sensors in the dispenser that must be taken care of. The first two can be found by carefully opening the top cover. They are located at the bottom floor of the dispenser. These sensors must be cleaned using a cotton swab.

Older models of dispenser may only have one sensor at the bottom.

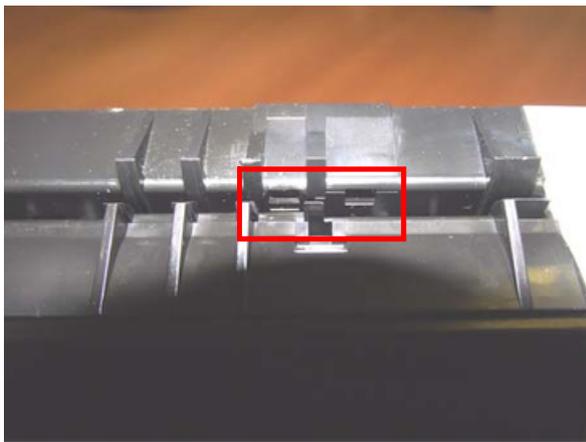
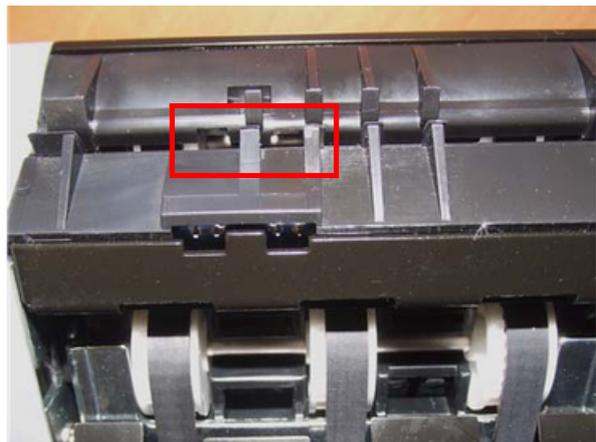
Bottom Sensor

The third sensor is located at the bill entrance (entrance of the bill from the path switch). It should be cleaned using a new cotton swab

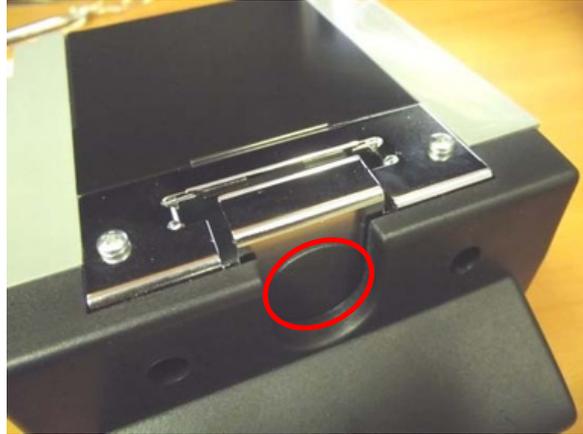
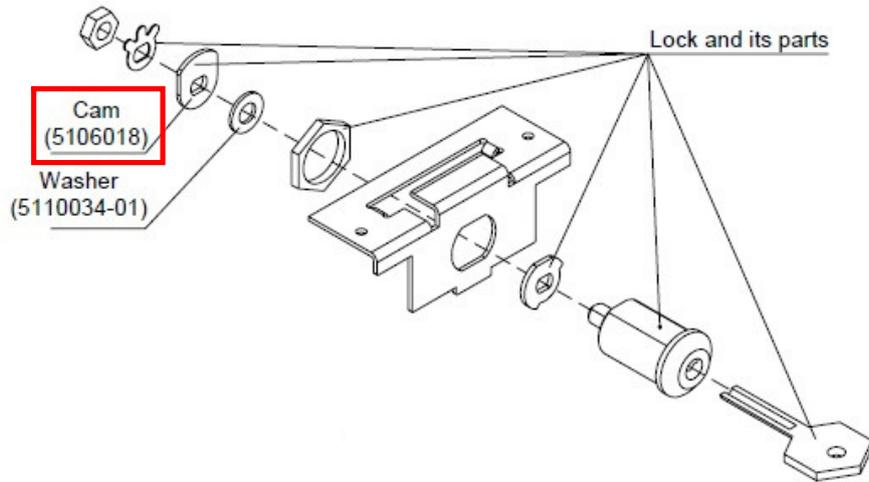
Additionally, special care should be taken when examining the cam lock mechanism on the dispenser. In many cases it may be bent or misshapen. This could compromise the security of the unit. Ensure that it is replaced as soon as any damage has been detected.

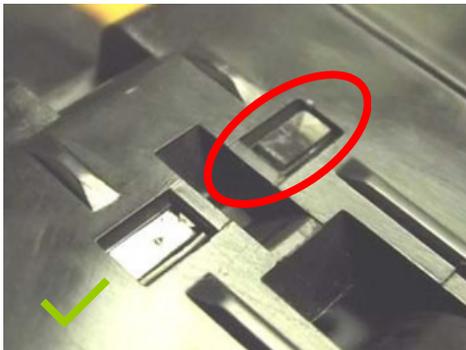
Properly installed lens (sunken)

All sensor sets should be first cleaned according to Level 1, however, as they are being cleaned, ensure that none of the rectangular prism lenses are protruding due to a potential of validator being dropped. If a protruding lenses are found on the surface of the bill validator's compartments (by passing a piece of paper or a card over them and having it hit the lens), simply press it down lightly in order to place it back into its original position.

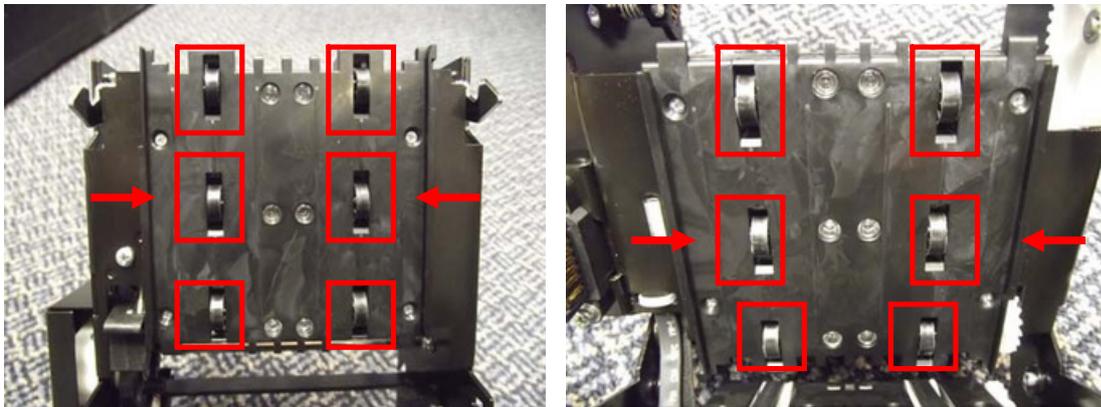
On the opposite side of the belts, 12 guide wheels are embedded in the bill path and should be cleaned using a pair of tweezers and a Suzo-Happ dummy card as previously mentioned.

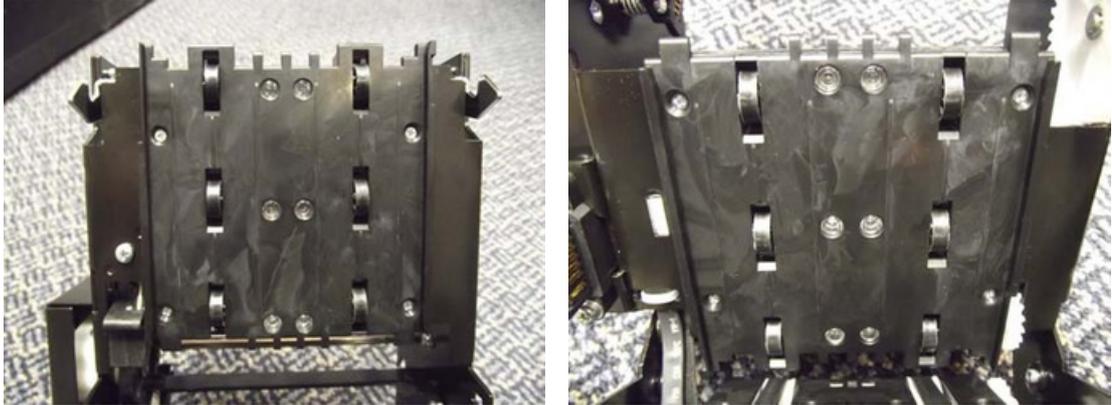
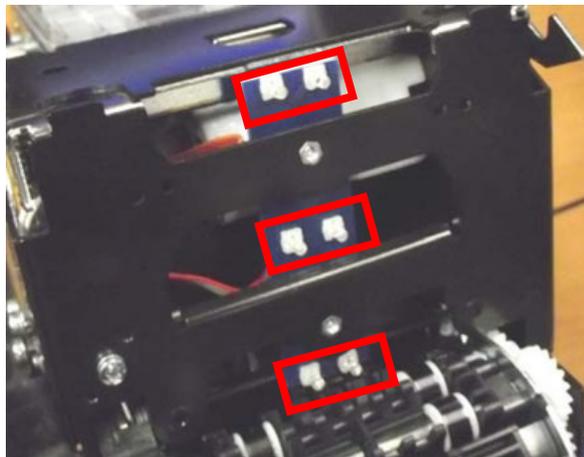
Additionally, it is recommended to remove the guide assembly and clean the sensors located below the lenses using a cotton swab followed by a can of compressed air. The guide assembly can be lifted after removing the four screws holding each assembly in place.

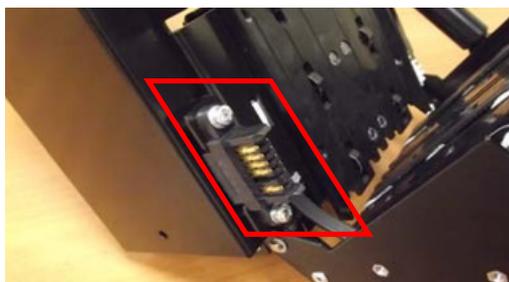
Also, inspect all the connectors on the chassis and ensure the connectors are neither bent nor damaged. Report any damaged connectors to a technician in order to replace the part.

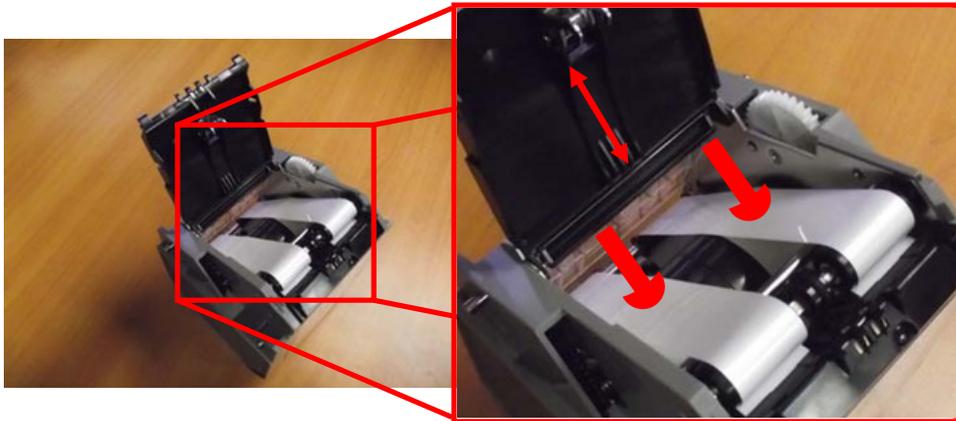
Next, inside each cassette two white, parallel tapes are found. Using a soft blunt object, or ones finger pad press down each tape in a location where no wheels or drums are present, press it up 1" down. Some resistance should be felt. Then, by quickly removing the object or ones finger, one should observe a spring-back effect of the tape (it should not remain loose)

Do not unwind the tape and ensure no oily residue is left on the tape to maintain proper functioning of the recycling cassette (use of gloves is highly recommended)

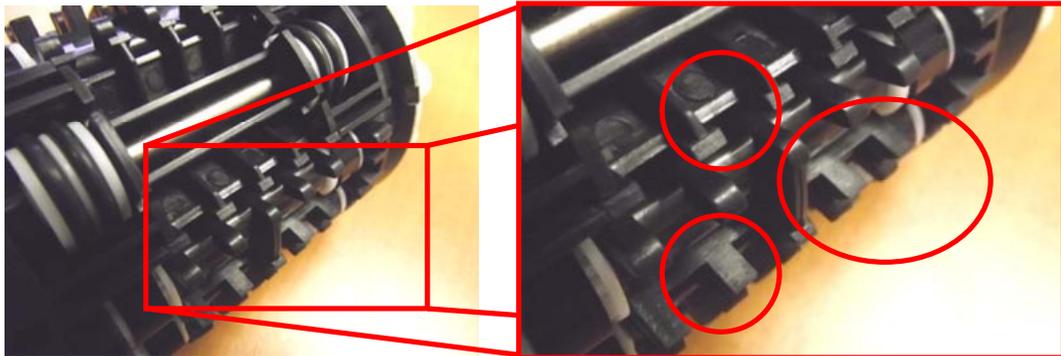
Inspect the path switch for damage. Some possible issues may include broken and chipped teeth on the switch.

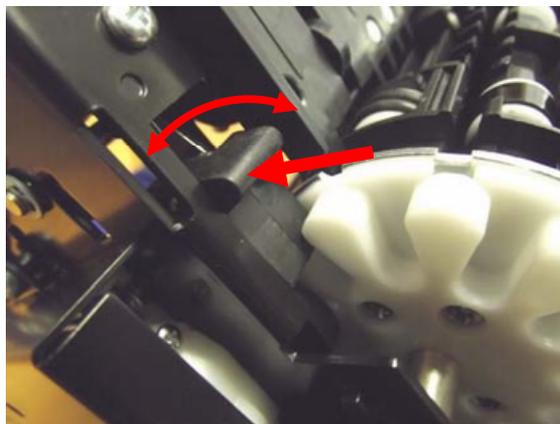
Also ensure that the switch lock works properly by first depressing it and then releasing it. The lock should snap back into its original position..

If any damage is found, or if the lock remains depressed, contact a technician for further instructions as the switch or locking mechanism have to be serviced.

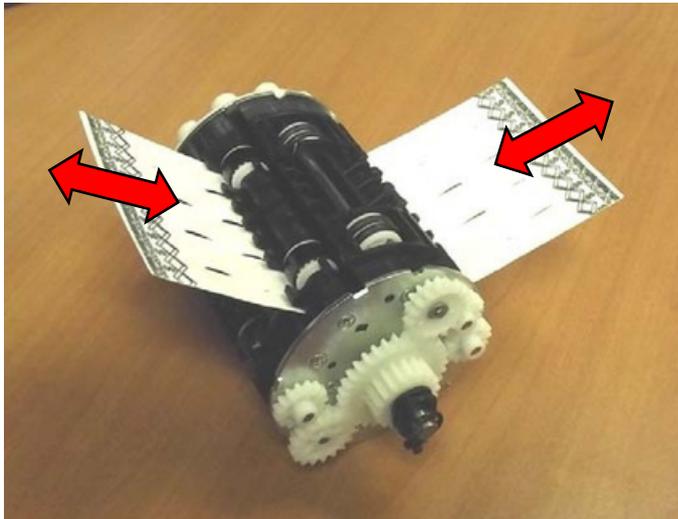
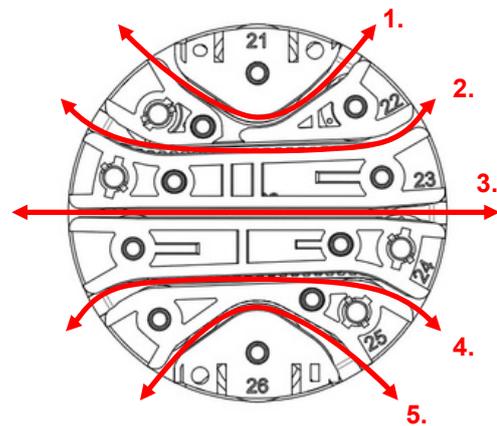
After the inspection, the switch can be cleaned using a cleaning card for bank note acceptor. First, open up the cleaning card pouch and ensure it is moist. Insert the card into the first slit and turn the gears on the side of the switch to slide the card halfway into the switch (as seen in the figure below).

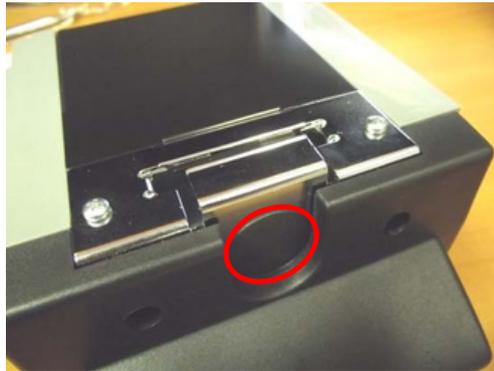
As before, ensure no physical damage is observed on the dispenser and report any excessive damage if found to a certified technician for further analysis. Special care should be taken when examining the cam lock mechanism on the dispenser. In many cases it may be bent or misshapen due to the mishandling of the unit which will compromise its security. Ensure that it is replaced as soon as any damage has been detected.

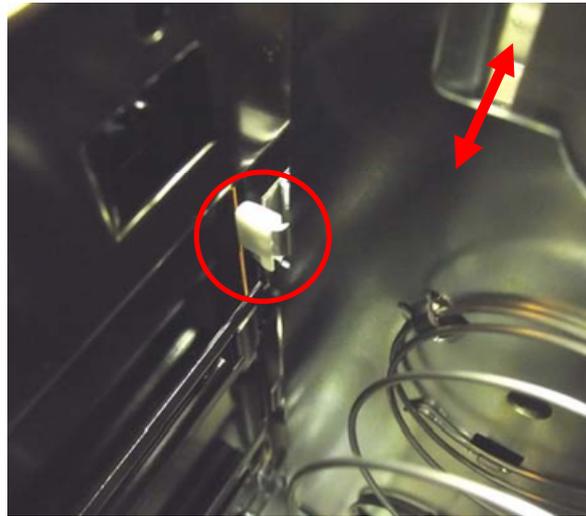
Next, inspect the inside of the cashbox for any damaged surfaces. Ensure the plate stacking the bills moves freely and that the pins used by the plate for sliding are not bent or damaged. The stacking plate supported by the springs must be straight. If any damage is found, please contact a technician for further analysis.

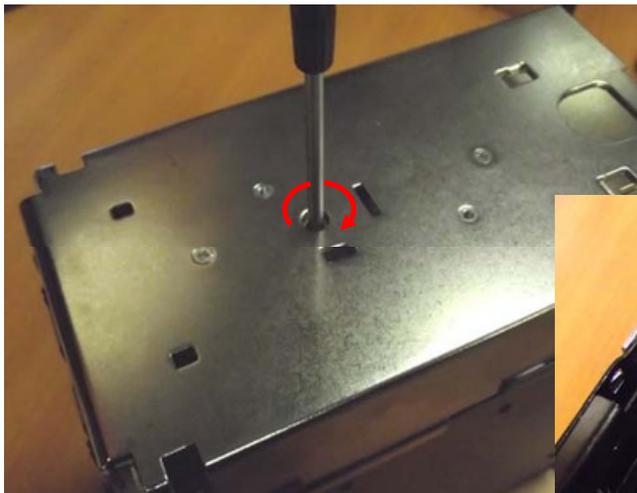
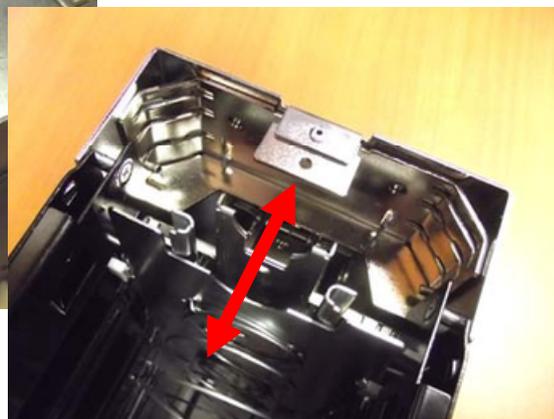
Additionally, flipping the cashbox reveals the stacker drive mechanism. This is the mechanism that drives an internal plate that pushes the bills into the cashbox as they come from the Bill-to-Bill™ 300 chassis. The mechanism can be checked to be free of any damage by inserting a Philips screw driver or tweezers and rotating it 2-3 revolutions.

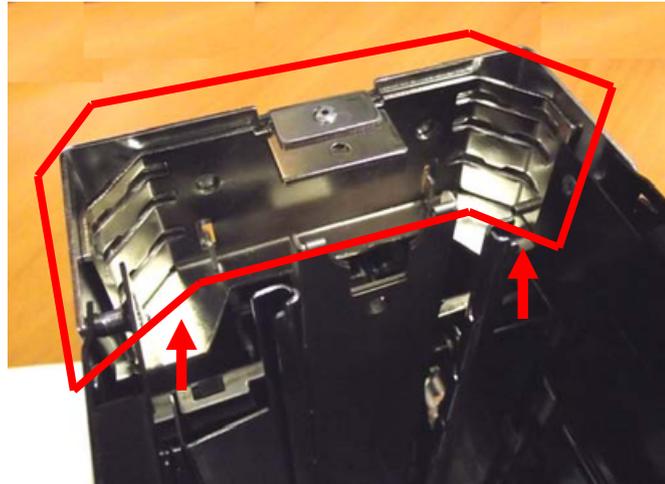
Visually inspect the cashbox cam used to lock the cashbox and ensure it is straight. Bend cams will compromise the security of the cashbox and must be checked often and replaced immediately if damage is detected (5106025).

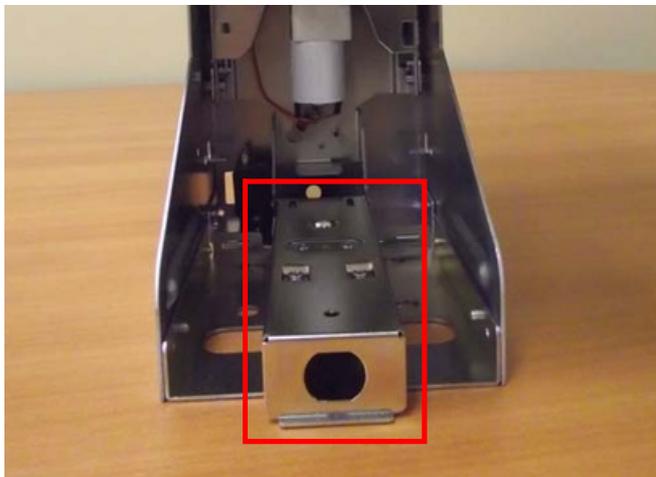
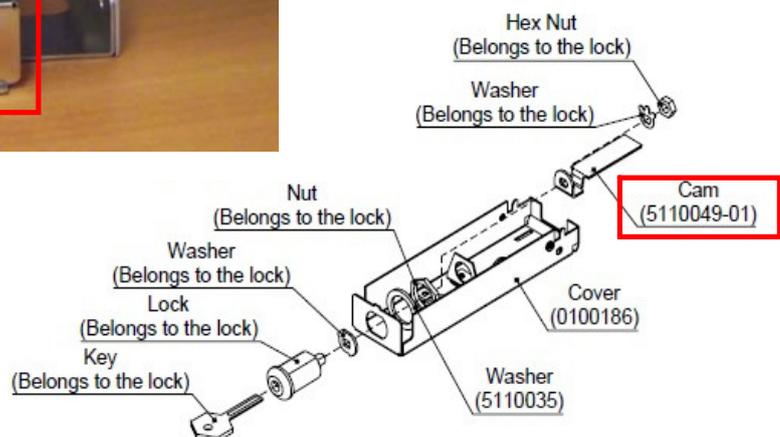
Additionally, inspect the housing cashbox cam located in the lock mechanism below the cashbox in the chassis for damage. If the cam is found to be bent or misaligned, a new housing cashbox cam must be ordered.

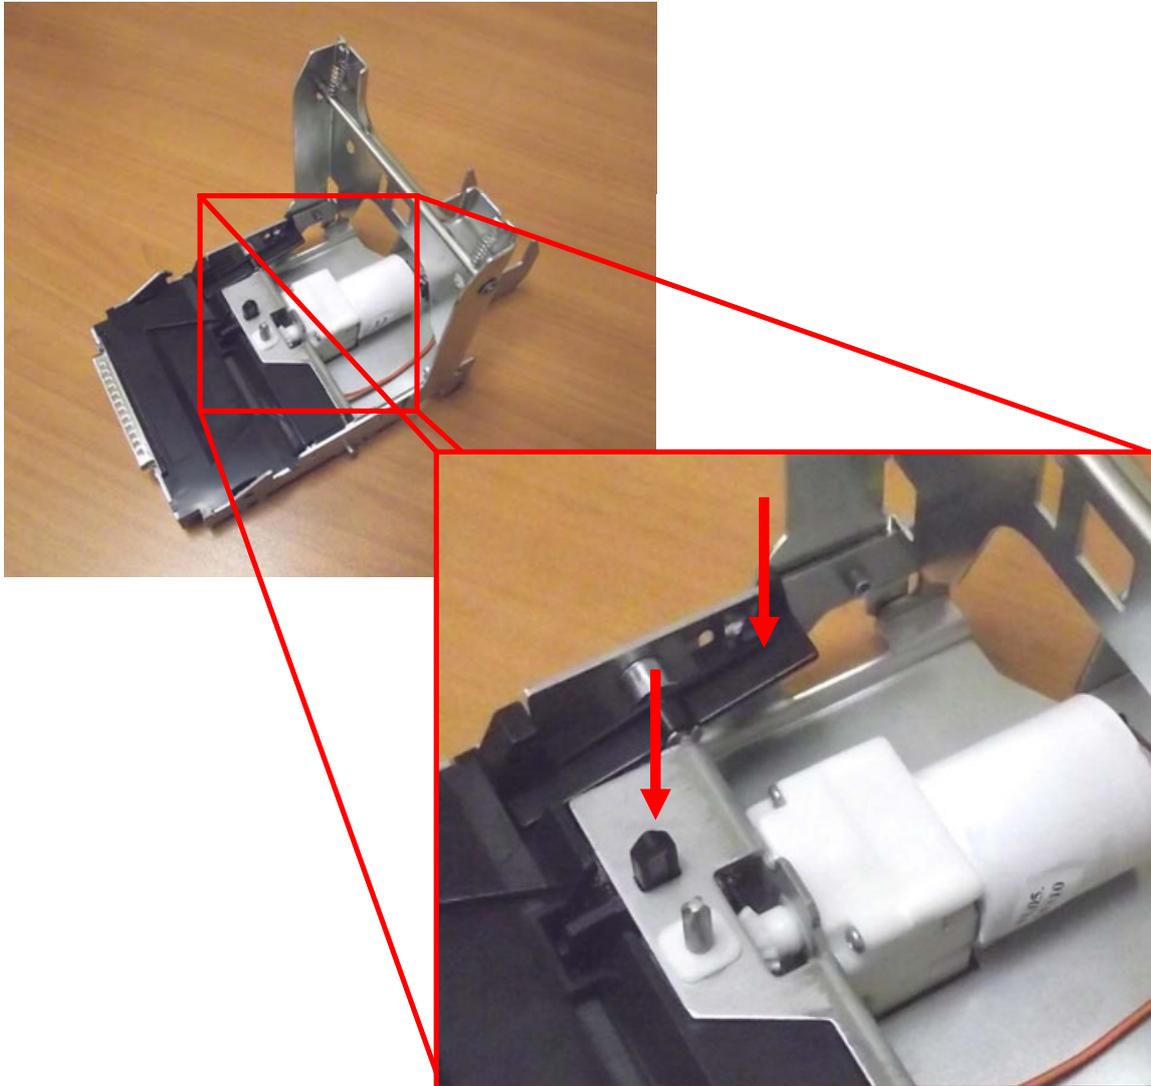
After the interface has been removed, check to ensure the two touch sensors are working properly by pressing them and ensuring they go back to their original position after they have been released.

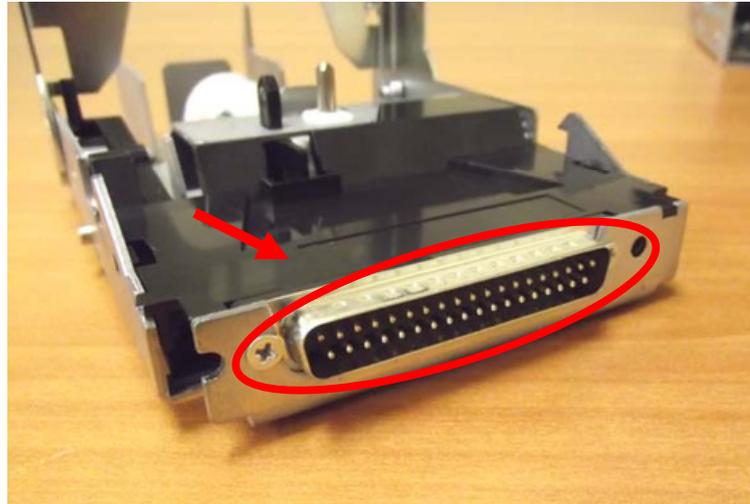
Also, ensure that the connector is not damaged and that all the pins are straight to ensure proper communication between the housing and the cashbox.

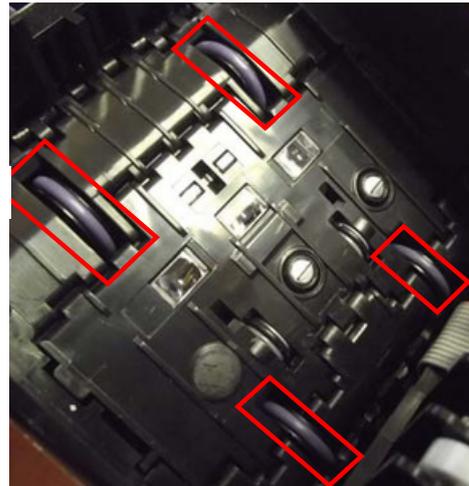
Lower Compartment

The o-rings (8211335) as well as the rollers (0200050 and 0200053.01) should be replaced at this stage to ensure proper traction along the bill path. A high level of disassembly is required to accomplish this step. The o-rings outlined below must be replaced.

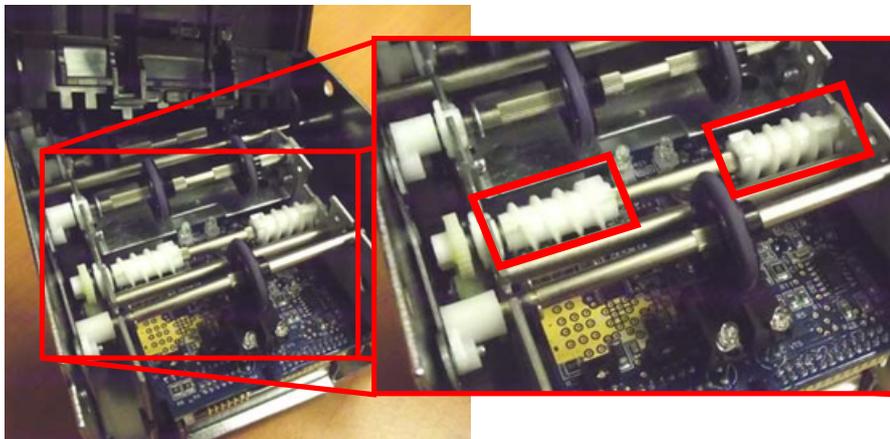
As the o-rings are being replaced, ensure the aligning mechanism worm gears are not damaged and clean them using a can of compressed air.

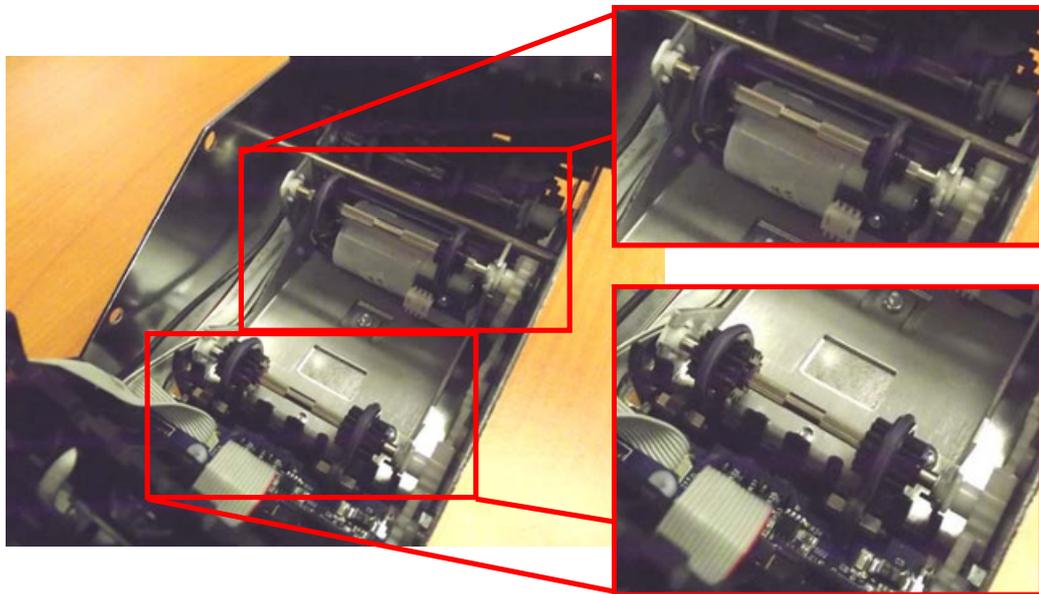
Next, replace the 4 o-rings and 4 rollers in the lower compartment similarly to the way it was done in the upper compartment.

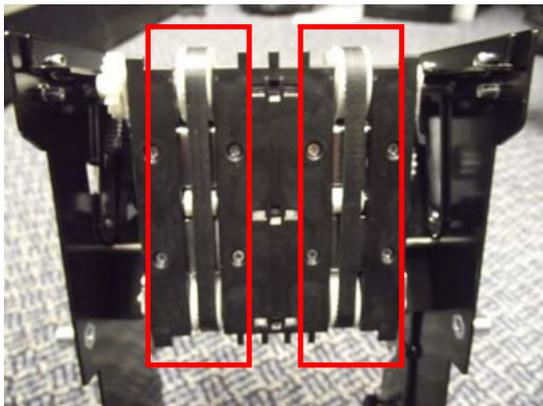
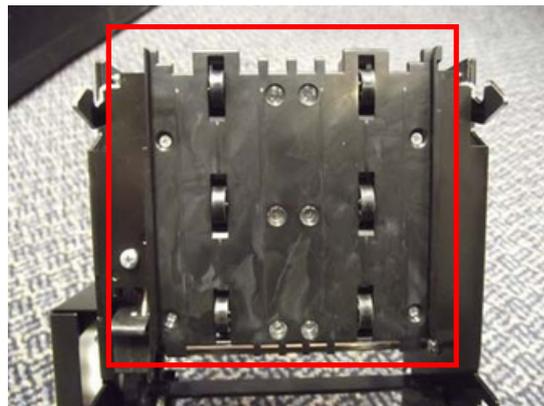
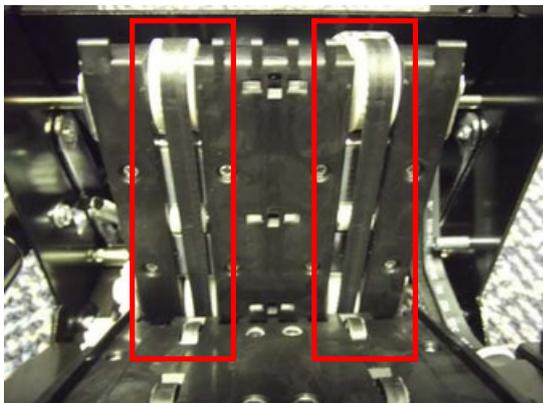
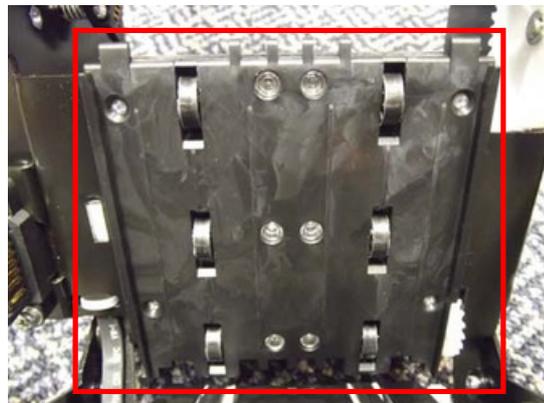
On one side of the chassis all four sets of belts (8215004) are replaced with a new set. On the opposite side of the chassis all 12 rollers are to be replaced along with the roller panel (0200111 or 0200111V3 - see note below for more details) to ensure proper traction and transport of the bill. This step requires an intermediate level of disassembly in order to perform the replacement.

The roller and belt assemblies in unit above are secured using screws, older models however may use black snap-in clips. The clips can be popped out using a flat-head screwdriver. While the rollers and belts are replaced, ensure the sensor board as well as the sensors on the board underneath are cleaned using cotton swabs and then sprayed using a can of compressed air.

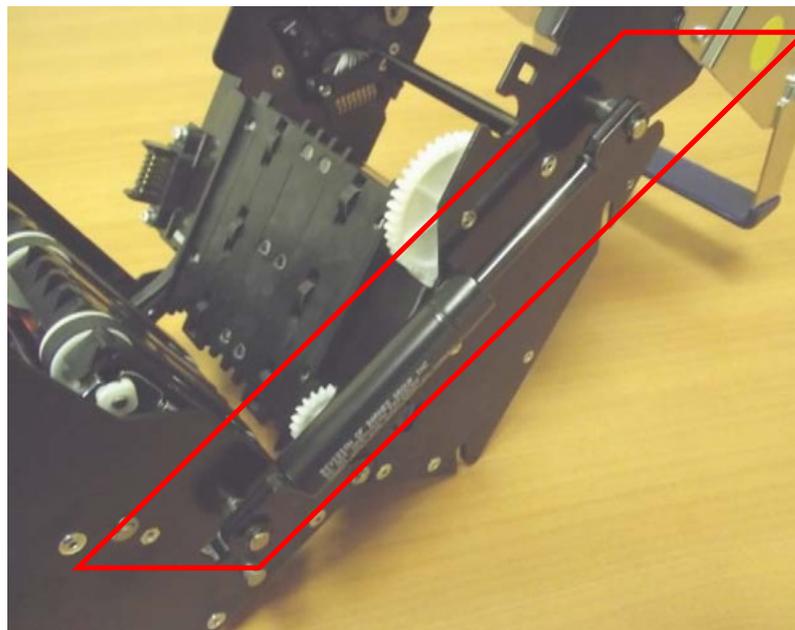
The spring arm (8601001) can also be replaced at this point to ensure a smooth opening and closing of the chassis and to avoid damage to the connectors between the two halves of the chassis.

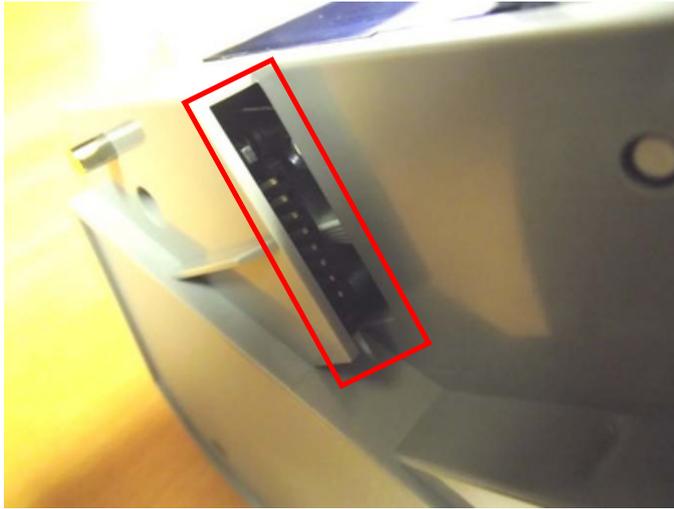
After performing the Level 2 maintenance, an additional step required is to ensure the interface connectors are intact on all recycling cassettes and do not show excessive signs of wear.

If any damage is detected, replace the connected along with the connector wire (0500109) by removing the two side covers of the cassette and unclipping the wire.

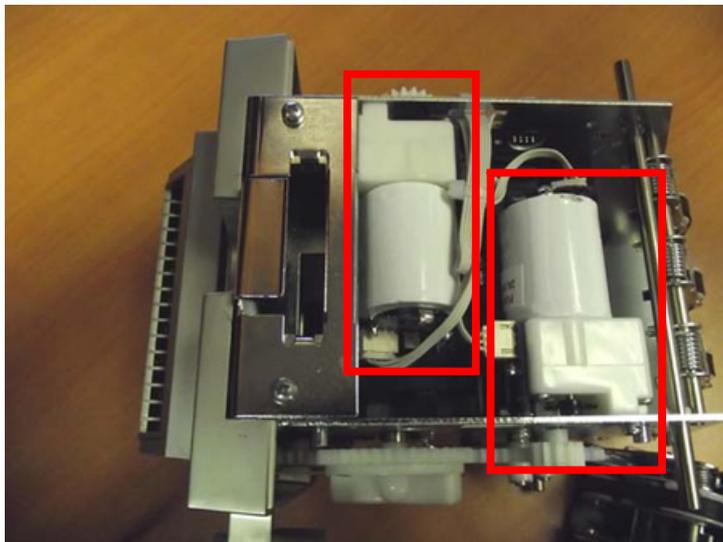
Optional: Turning the dispenser over would reveal the shutter and drive motors. It is recommended to replace these motors during Level 3 maintenance at **540,000** cycles (0300052-02).

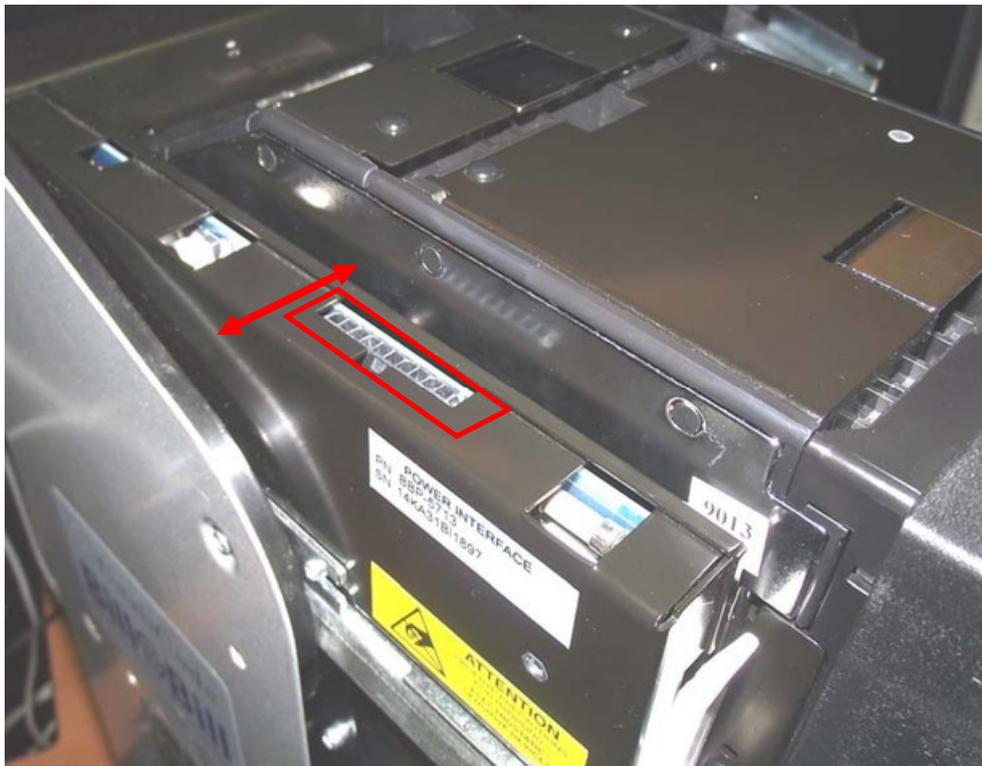
The power interface is an essential life-line for the Bill-to-Bill™ 300 unit. Ensure that the connector is not loose and has no play about its location. Also, ensure the pins inside each of the 10 slots on the connector are straight. If any damage is detected, the power interface must be replaced.
